Manhole Inspection Summary

Manhole # S15MM1002MH

Insp Date: **12/6/06 9:59 AM**

Location Address: **4555 LANIER AVE**

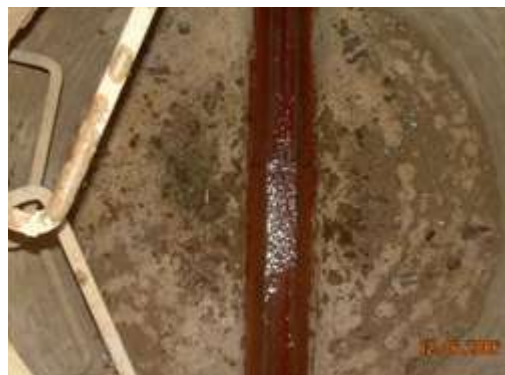
Top View

Frame Offset: **0** (in.) Condition: ☐ Sound ☐ Cracked ☒ **Leaks**

Infiltration: ☐ None ☒ **Joint** ☐ Cracks ☐ Mortar ☐ Roots ☒ **Wall**

Bench ☒ Exists Material: **Brick** ☐ Parged ☒ **Debris** (not Condition related)

Frame leaks. Adjustment infiltration.
Bench debris.

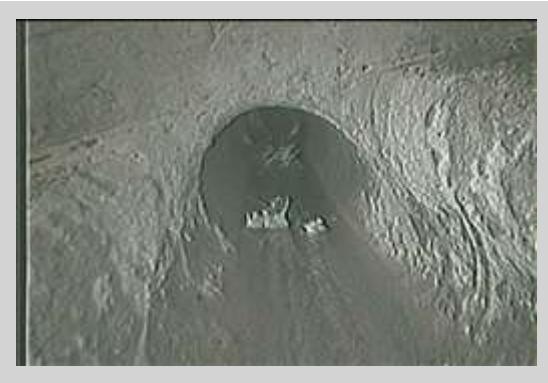
6 in. Circular Gravity Sewer Pipe Out @ 12 O'Clock

Infiltration: **Evidence** Pipe Seal Cond: **Unknown**

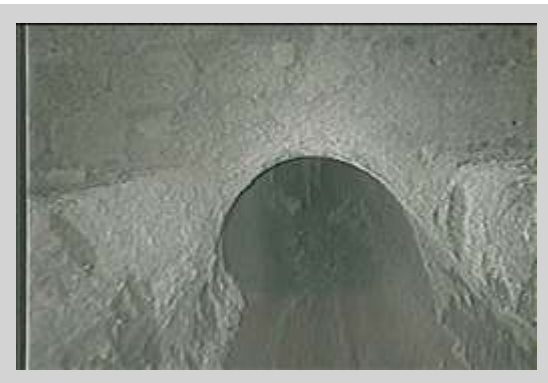
8 in. Circular Gravity Sewer Pipe In @ 6 O'Clock

Infiltration: **None** Pipe Seal Cond: **Unknown**
